Client Report (National Research Council of Canada. Construction); no. A1-018329.1/A1-018487.1, 2023-05-10

Large-Scale Fire Tests of A Mass Timber Building Structure for MTDFTP

Report No.: A1-018329.1/A1- 018487.1

Report Date: 10 May 2023

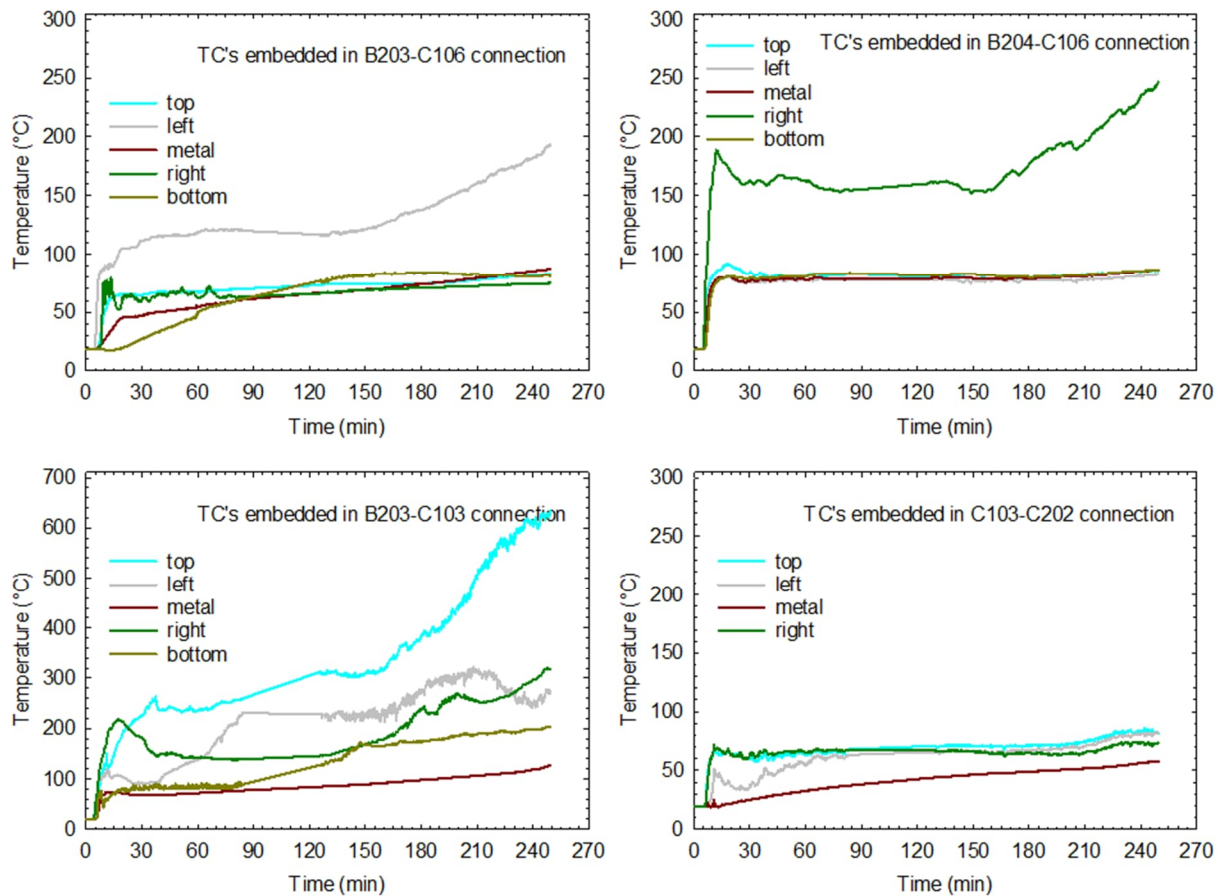
Figure 18. Temperatures in mass timber connections during Test 5.

For the B203-C103 beam to column connection, three of the five thermocouples measured the temperatures of over 300 °C at the top, left and right positions with the top thermocouple reaching 630 °C at the end of the test. This connection continued smouldering during and after the test, requiring considerable efforts in the post fire operation to fully extinguish the hidden hot spots in the ceiling-beam-column junction. Possible causes for this are discussed in Section 3.3.5.

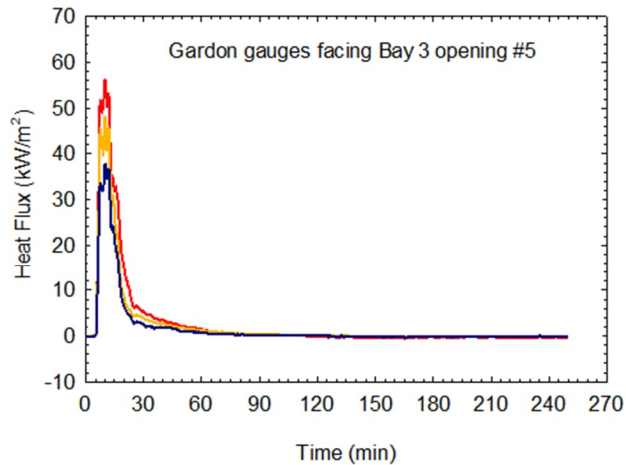
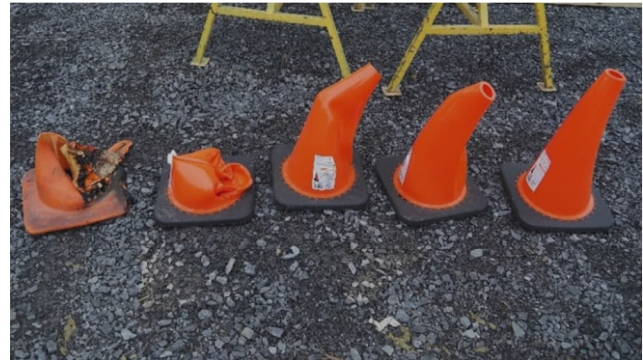
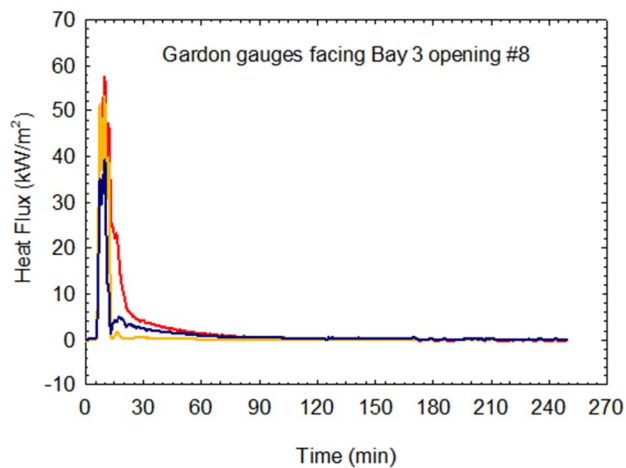
Damaged plastic safety cones (from left to right) which were placed at 11, 14, 17, 21 and 24 m away.

The heat fluxes measured at distances were consistent with visual observation, videos and photographs pertinent to heat exposure of the surrounding objects. **Figure 23** includes photographs of damaged plastic safety cones (collected after the test) and deformed plastic casing of large display screens. These safety cones were placed at 11, 14, 17, 21 and 24 m away from the structure during the test. They melted or deformed during the first 18 min of the test. The grass within 20 m to the window openings started to burn at 9-13 min (water had to be sprayed to cool down the grass). Two cameras installed at 11 m away from the test structure started melting at 12 min (lost function at 30 min). Plastic casing of two large display screens placed at 30 m away also deformed noticeably.

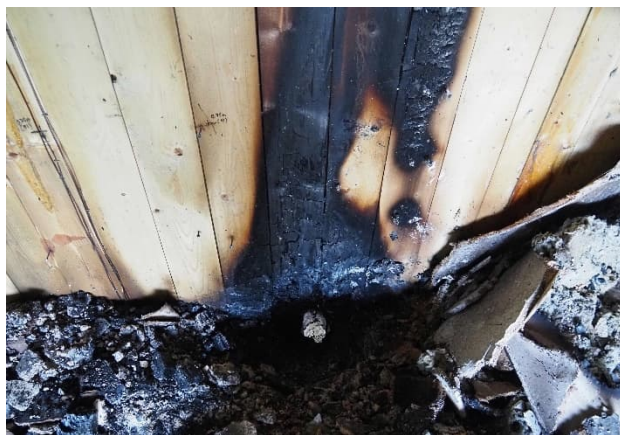
The CLT floor assembly endured the fire exposures from both sides in multiple fire tests. The preceding Test 5 already created deeper charred pockets along the junction of the CLT floor/ceiling assembly with the shaft wall from the underside. During Test 2, a hole was completely burnt through the CLT junction from above as the result of the combined fire exposures from Test 2 and Test 5, as shown in **Figure 40**.

(a) hole in CLT floor-shaft junction (gypsum board removed from the shaft wall and floor)

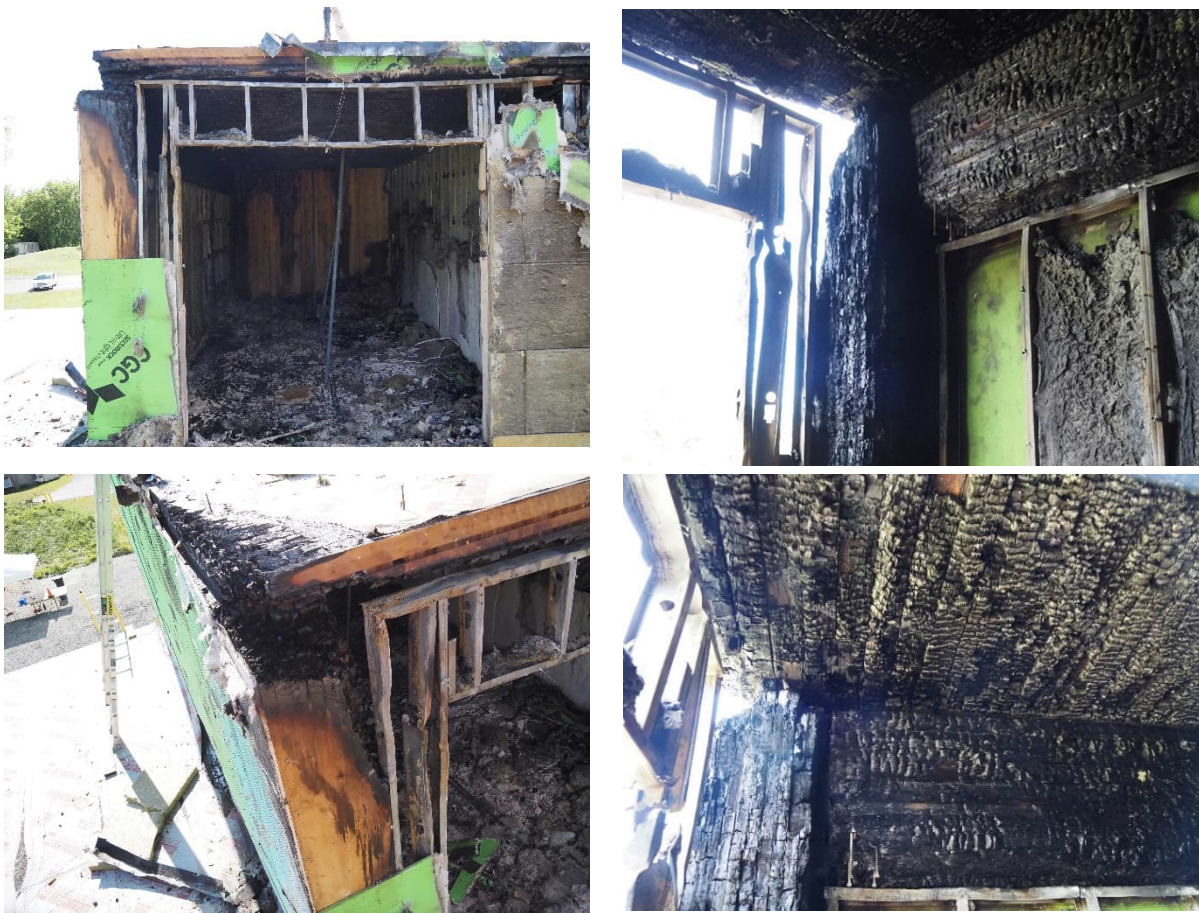
Figure 42. Charring near the B301-C201 beam-column-ceiling junction from Test 2.

only 70 mm of wood remaining. The fire burnt through between the beam and column connection, leaving a large hole in-between, and the metal connector was visible from both interior and exterior. The cross section of the top portion of the column was reduced from 395 mm × 395 mm to 300 mm × 275 mm (charred away 95 mm and 120 mm respectively). The column also lost 160 mm in height, leaving a 300 mm gap between the column and the charred ceiling in the corner. This continuous smouldering was likely related to the compromised firestop installation in the construction phase. A single bead of firestop caulking had been applied in the joint between the CLT ceiling panel and the top of the column, which seemed inadequate for this corner geometry along with the negative impact of rain on the firestopping. A 5-mm gap had been spotted in the beam-to-column connection after the construction. The manually installed connection hardware and various mass timber products from different manufacturers/suppliers could not achieve the fit as good as those typically produced using the CNC technology with high precision. Although firestop calking was applied to fill the gap, it could not completely seal the connection due to the obstruction by the exterior wall. Also, the lightweight steel exterior wall assemblies were not built as airtight as normal buildings (not well sealed in the joints with the mass timber beam, column and ceiling), providing passages for hot gases to move through and smouldering to continue during the 4-hour fire test and 1-hour post test operations. However, the issues were unique to the test structure only. Normal buildings would have the structural elements and connections tightly fitted using the CNC technology, and their envelope would be more airtight to limit air leakage and convection heat in order to meet the NECB.
