Client Report (National Research Council of Canada. Construction); no. A1-018329.1/A1-018487.1, 2023-05-10

Large-Scale Fire Tests of A Mass Timber Building Structure for MTDFTP

Report No.: A1-018329.1/A1- 018487.1

Report Date: 10 May 2023

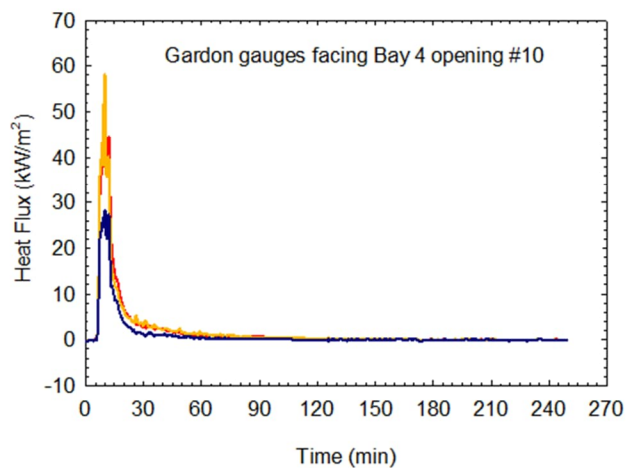
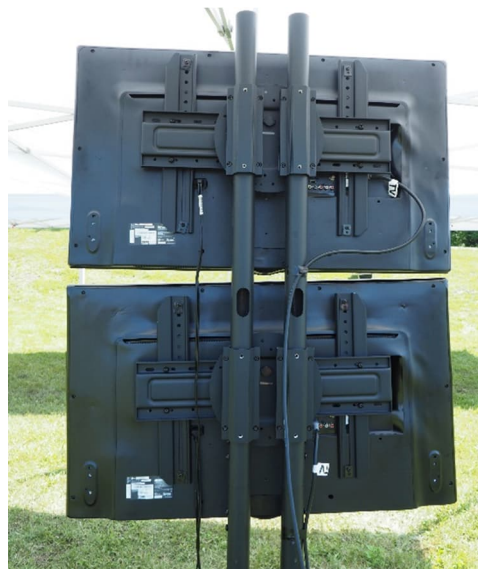
Figure 23. Heat fluxes at distance to structure's openings during Test 5.

Deformed plastic casing of display screens which were placed at 30 m away.

The heat fluxes measured at distances were consistent with visual observation, videos and photographs pertinent to heat exposure of the surrounding objects. **Figure 23** includes photographs of damaged plastic safety cones (collected after the test) and deformed plastic casing of large display screens. These safety cones were placed at 11, 14, 17, 21 and 24 m away from the structure during the test. They melted or deformed during the first 18 min of the test. The grass within 20 m to the window openings started to burn at 9-13 min (water had to be sprayed to cool down the grass). Two cameras installed at 11 m away from the test structure started melting at 12 min (lost function at 30 min). Plastic casing of two large display screens placed at 30 m away also deformed noticeably.

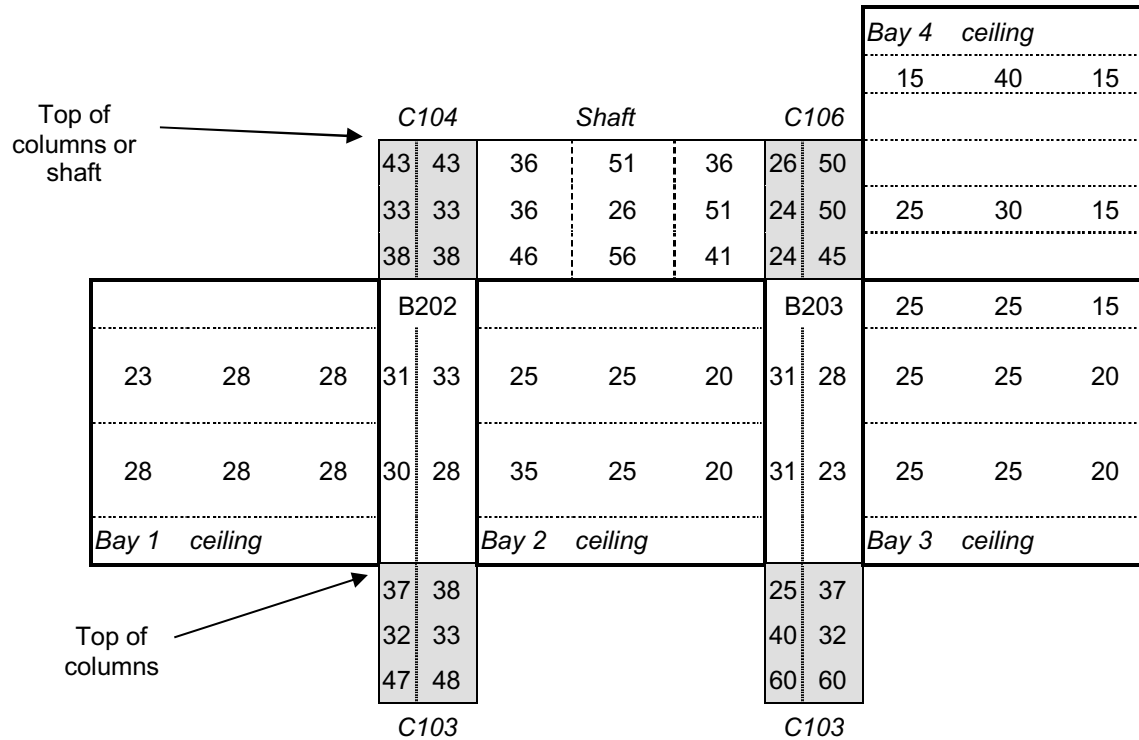
Figure 24. Char depths (mm per exposed side) in ceiling, shaft, beams and columns in Test 5.

The mass timber structural elements used in this test structure met the 2-hour fire-resistance rating, which were designed according to CSA O86-19 to allow charring from each exposed side. The Resistograph measurement results shown in **Figure 24** reflect an overall picture of the general char depths in Test 5, which are well within the design allowance. The vertical mass timber elements (shaft panels and columns) had greater char depths than the horizontal elements (ceiling panels and beams). Beams and columns generally had deeper charring at their two ends. The averaged char depths are 24 mm for the ceiling panels, 29 mm for the beams, 39 mm for the columns and 42 mm for the shaft panels.

Several locations, especially joints and connections, were observed to have greater char depths than the values shown in **Figure 24**. There was a concentration of severe charring that caused a hole at the bottom of the CLT shaft beside the column C104, as shown in **Figure 25 (e)** and **(g)**.

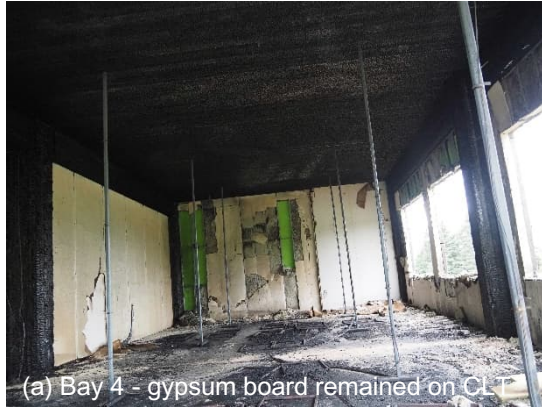
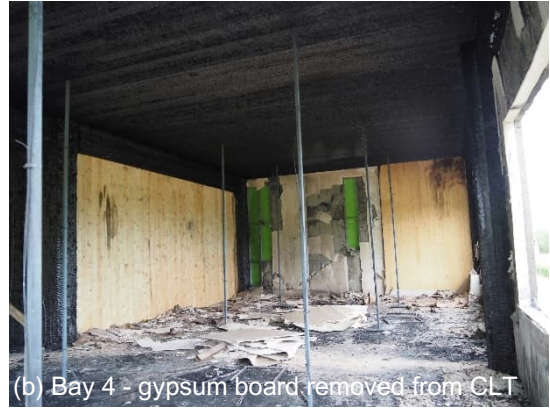
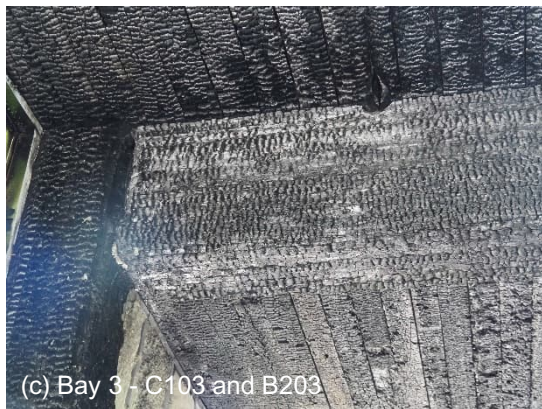
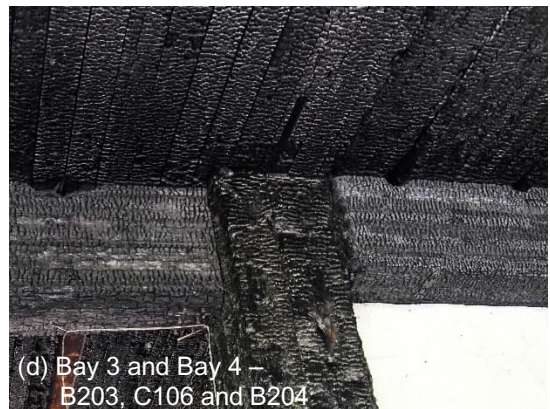
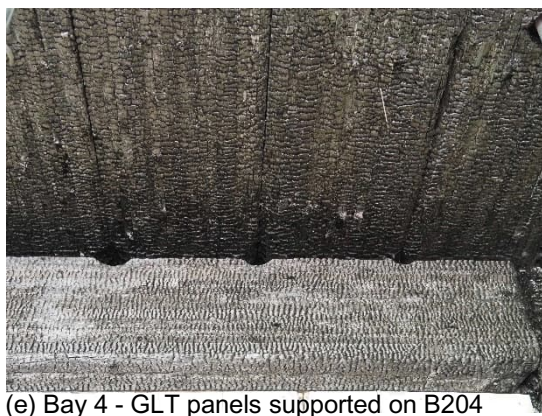
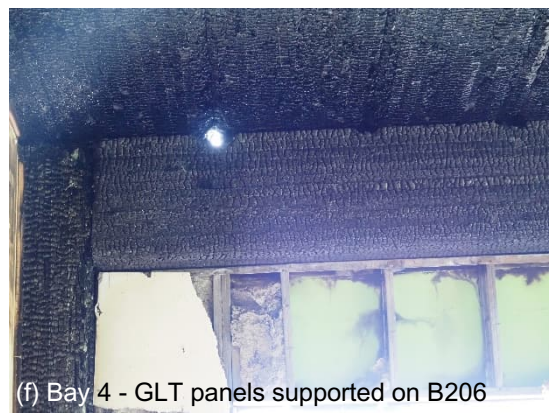
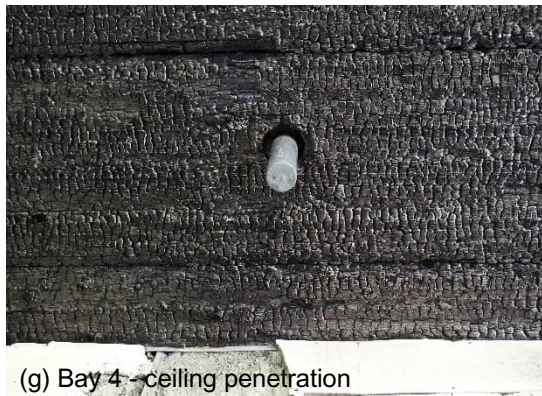
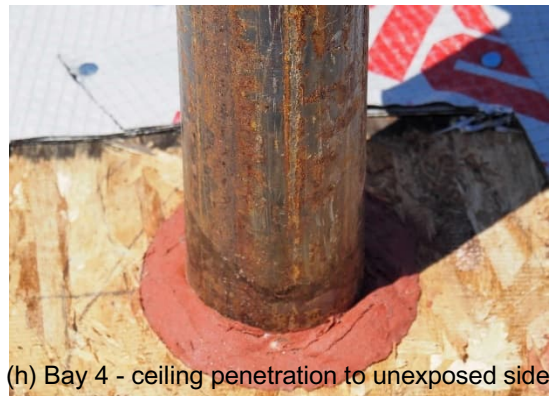
Figure 27. Photographs of Bay 3 and Bay 4 after Test 5.

For the two pipe penetrations through the ceiling in Bay 1 and Bay 4, firestop sealant around the cast iron pipes had no visual changes on the unexposed (roof) side as shown in **Figure 27** (g) and (h) as well as **Figure 25** (b).

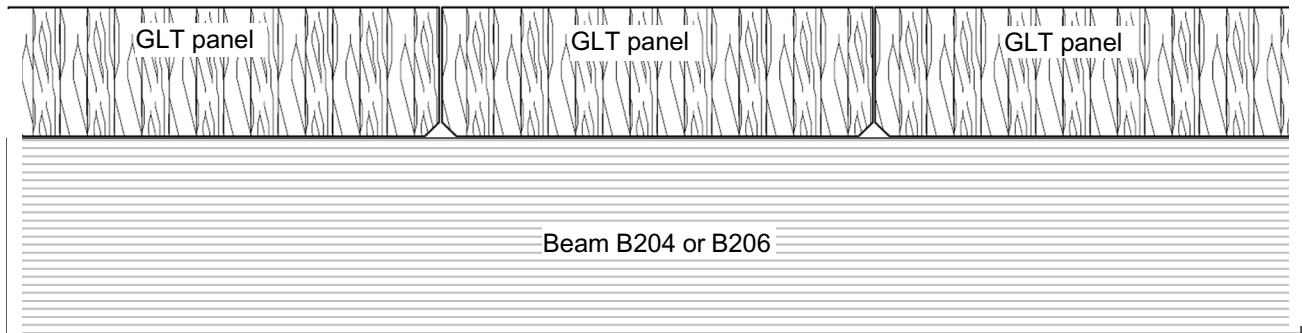
Figure 28. Butt joints of GLT panels with profiled edge supported on beams.

However, deeper charring due to smouldering was observed at several locations, especially at joints and connections. There were also deep burnt pockets at several junctions of the ceiling panel butt joints on top of the beams and at the bottom of the CLT shaft beside the column. It was believed that the firestop installation was compromised by the rainy weather during the construction – some firestop caulking was washed away by the rain during installation, compounded by the absence of normally used concrete topping on the floor/ceiling assemblies. The manually installed connection hardware and various mass timber products from different manufacturers/suppliers could not achieve the fit as good as those typically produced using the CNC technology with high precision. These negatively impacted the fire separation continuity of the floor/ceiling assemblies. Also, the perimeter walls of the test structure were not built as airtight as normal buildings. Although steps were taken to remedy the issues after the construction, physical obstruction by the finished building elements prevented some joints from getting a complete seal. These incomplete seals would likely have allowed hot fire gases to move through and caused continuous smouldering at the joints, in addition to the absence of firefighting intervention during the four-hour test. However, the issues were unique to the test structure only. For normal buildings, the CNC technology would be used in the production of the mass timber structural elements and the installation of connection hardware to provide tight fits, concrete topping would be poured on the floor assemblies and their building envelope would be airtight to limit air leakage and thermal transfer in order to meet the NECB.

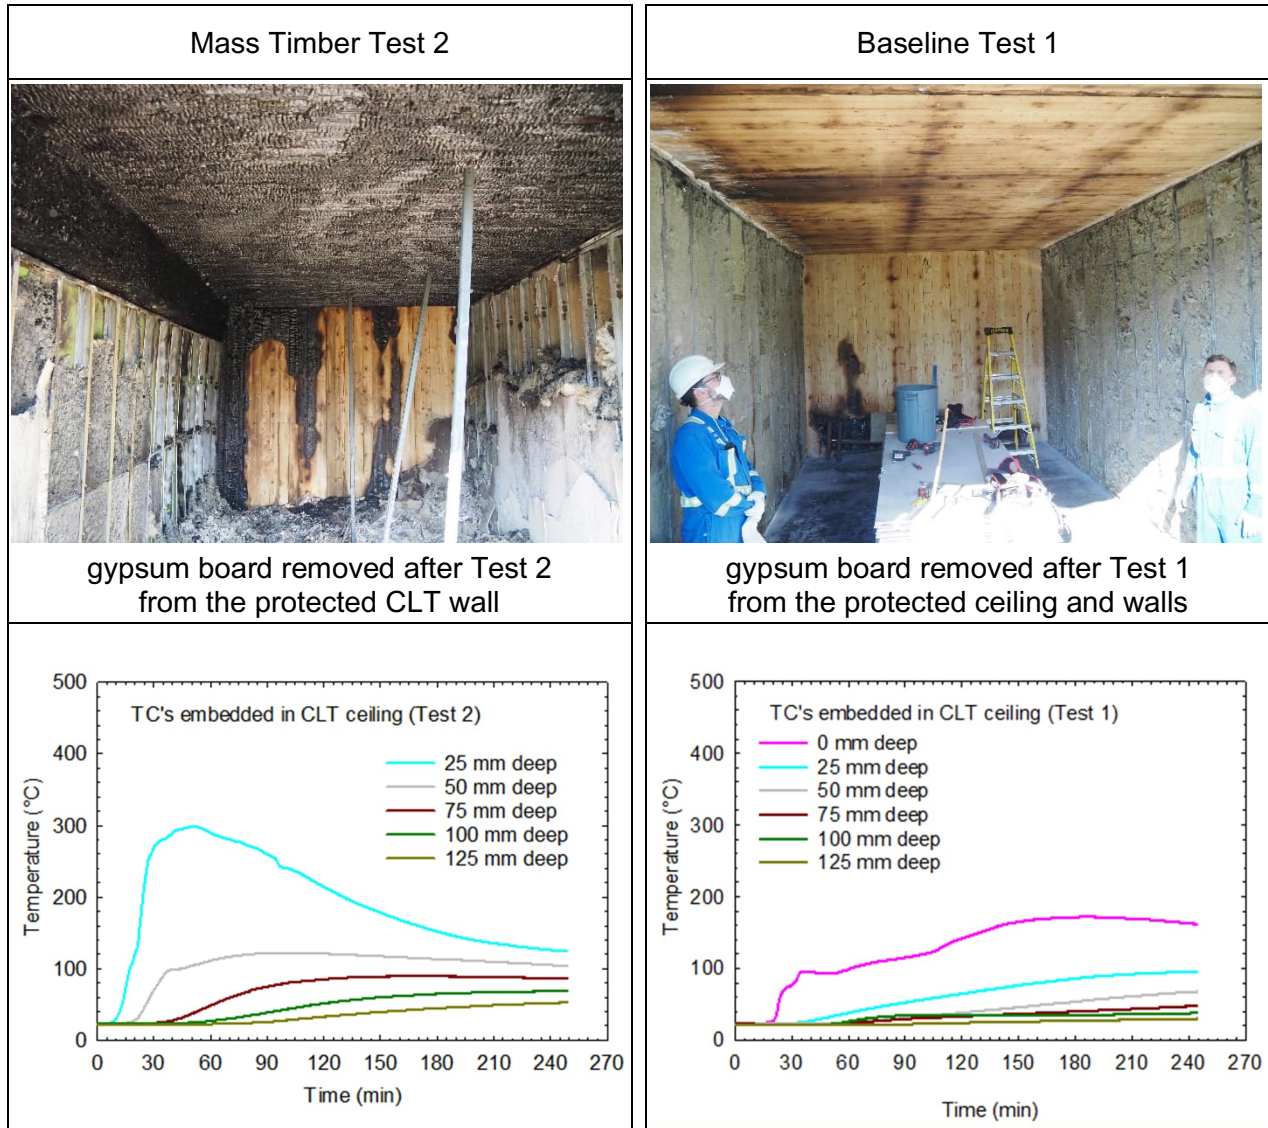
Figure 38. Comparing Test 2 with Test 1 – Charring on mass timber elements and temperatures in CLT ceiling.

In the Test 1 room, the CLT ceiling and most part of the CLT shaft wall had a few slightly darkened marks along the gypsum seams and screw spots. The temperatures measured at the CLT-gypsum interfaces were below 170 °C and the temperatures inside the CLT were even lower. There was some surface charring (up to 4 mm) at the bottom of the CLT shaft wall due to the persisted glowing embers on the floor at the back of the room. This minor charring should have negligible effect on the fire dynamics of this baseline test, which was intended to represent a fire scenario in a building of noncombustible construction.

During Test 2, the peak temperatures measured inside the exposed CLT ceiling were 300 °C at 25 mm deep, 120 °C at 50 mm deep and below 90 °C at 75-125 mm deep (see data plots for Test 2 in **Figure 38**), which implies 25 mm < the ceiling char depth < 50 mm. The maximum temperatures at 25 mm deep were reached at around 50 min and then started to decrease, dropping to about 130 °C at the end of the test.

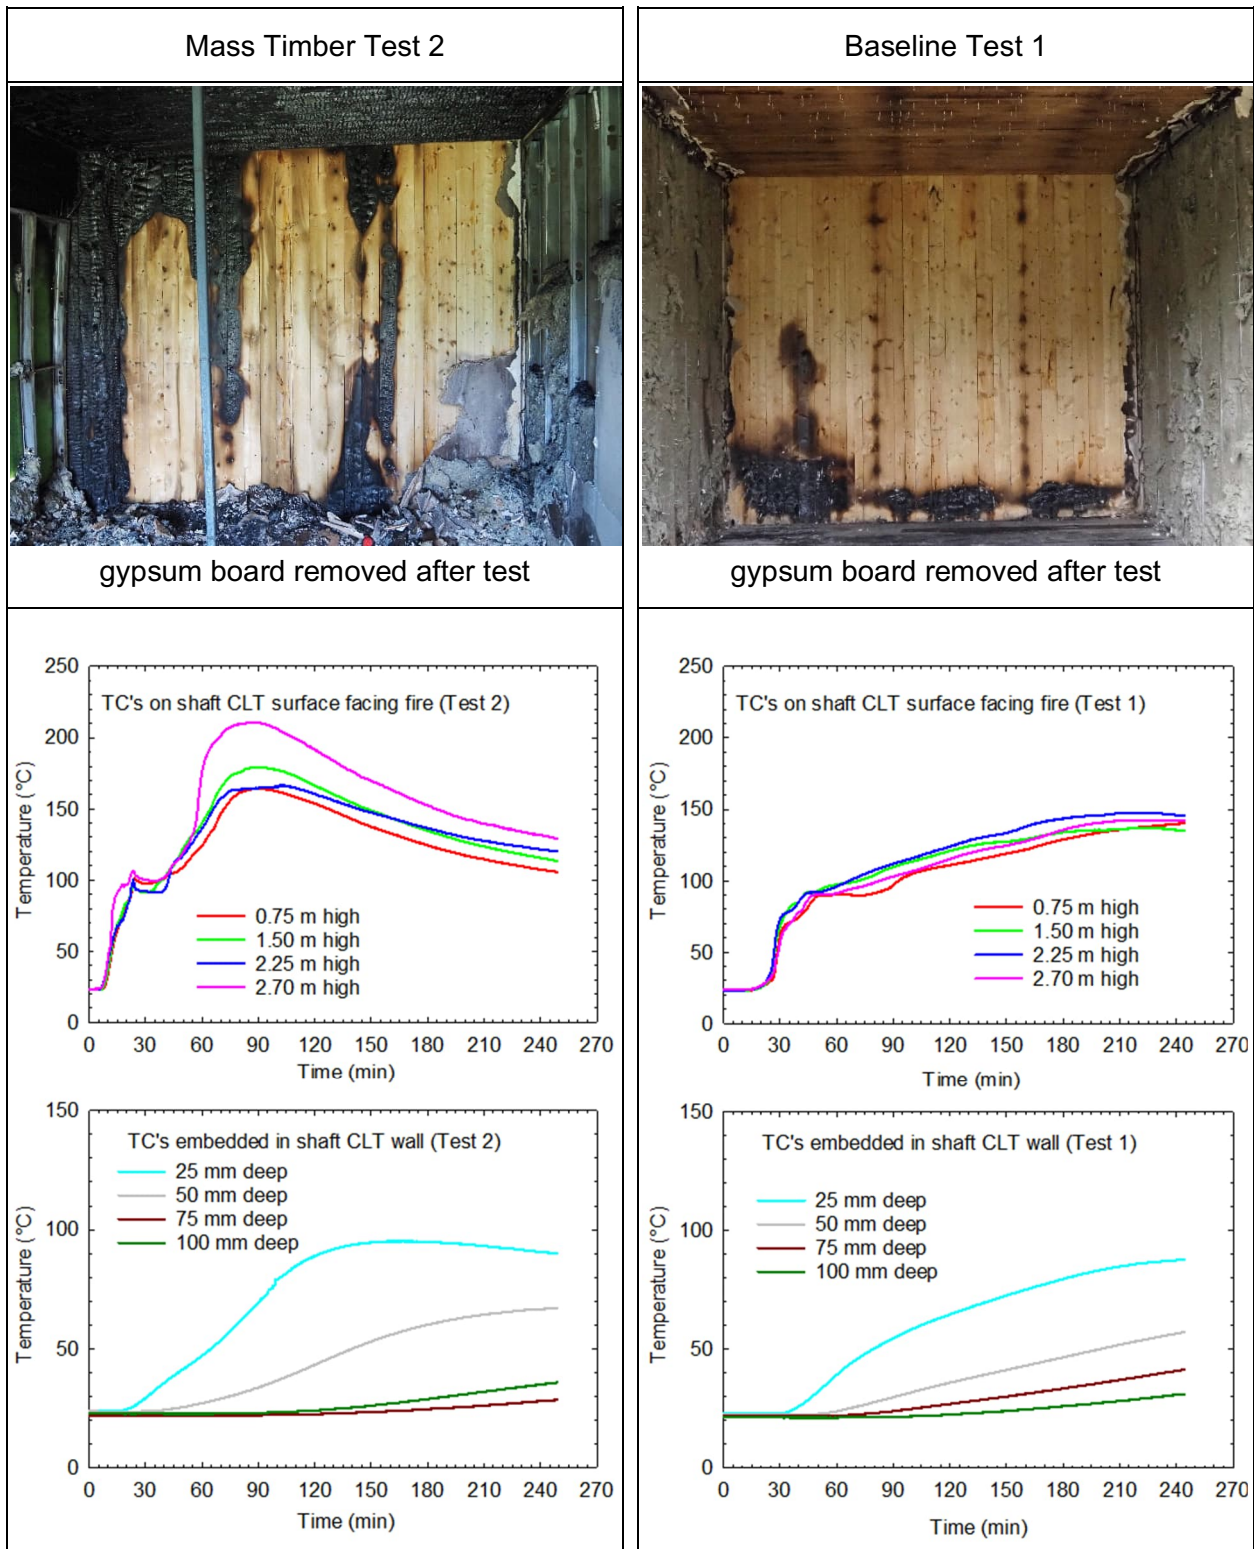
Figure 39. Comparing Test 2 with Test 1 – Temperatures in CLT shaft panels and charring behind gypsum board.

After the tests, the remaining gypsum board was removed from the protected structural elements. **Figure 38** and **Figure 39** reveal the state of the protected structural elements.

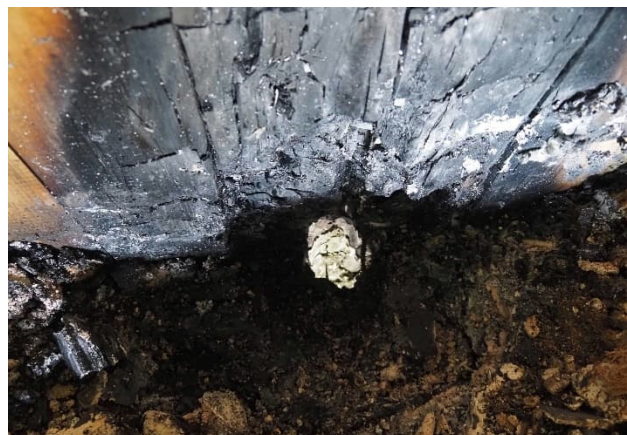
The CLT floor assembly endured the fire exposures from both sides in multiple fire tests. The preceding Test 5 already created deeper charred pockets along the junction of the CLT floor/ceiling assembly with the shaft wall from the underside. During Test 2, a hole was completely burnt through the CLT junction from above as the result of the combined fire exposures from Test 2 and Test 5, as shown in **Figure 40**.

(b) zoom into the junction

In addition to the two-sided fire exposures and the absence of firefighting intervention during the two long tests (Test 2 and Test 5), the rainy weather during the construction likely compromised the integrity of the firestop installation which was compounded by the absence of normally used concrete topping on the floor/ceiling assembly. The incomplete seal allowed hot fire gases to move through and caused the hole at the floor-wall joint. However, the issue was unique to the test structure only. For normal buildings, firestop would be applied in compliance with the NBC requirement, and concrete topping would be poured on the floor assemblies to limit the hot gas movement and convection heat transfer through the joint.

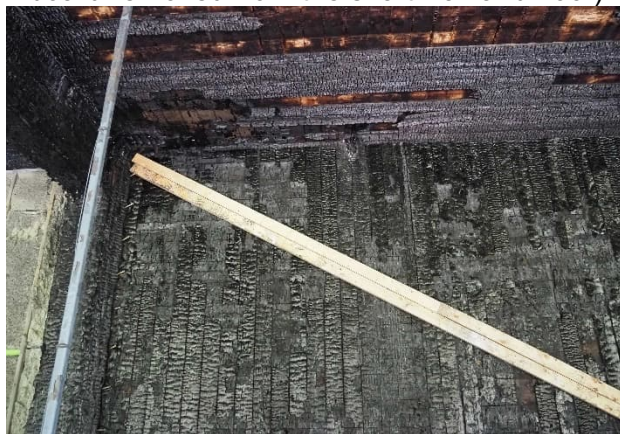
(c) hole in CLT floor-shaft junction (underside)

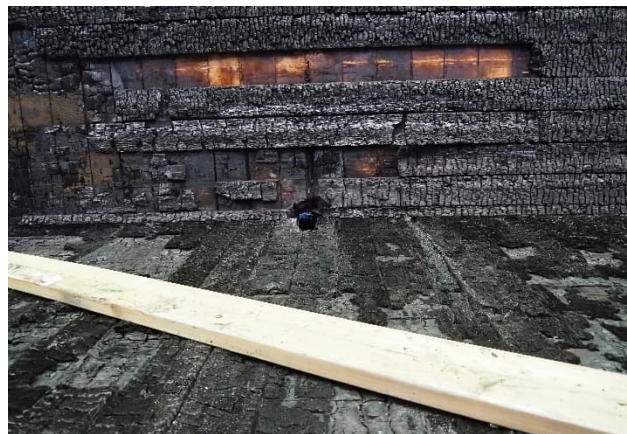
(d) zoom into the junction (underside)

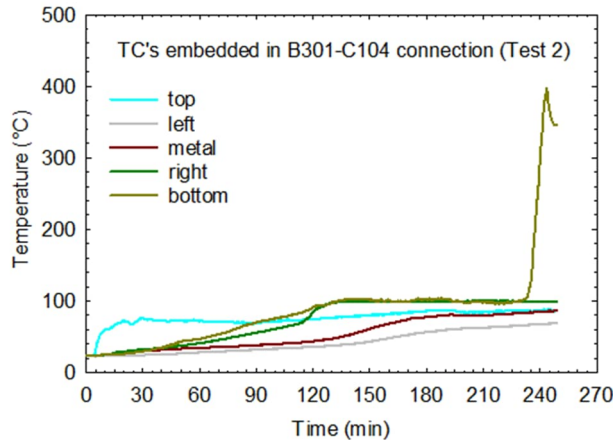
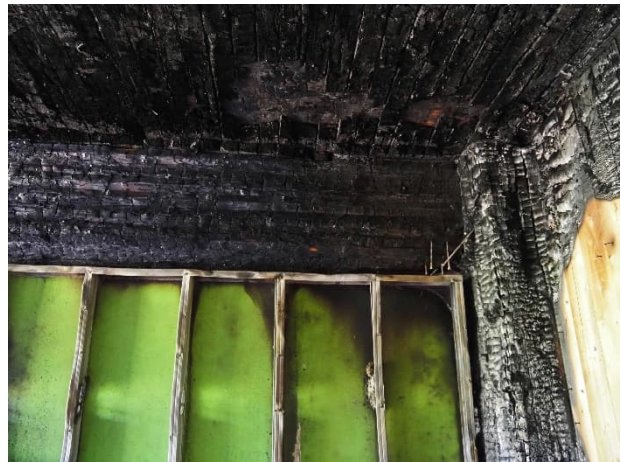
Figure 43. Charring and temperatures in ceiling-beam-column connection in Test 2.

only 70 mm of wood remaining. The fire burnt through between the beam and column connection, leaving a large hole in-between, and the metal connector was visible from both interior and exterior. The cross section of the top portion of the column was reduced from 395 mm × 395 mm to 300 mm × 275 mm (charred away 95 mm and 120 mm respectively). The column also lost 160 mm in height, leaving a 300 mm gap between the column and the charred ceiling in the corner. This continuous smouldering was likely related to the compromised firestop installation in the construction phase. A single bead of firestop caulking had been applied in the joint between the CLT ceiling panel and the top of the column, which seemed inadequate for this corner geometry along with the negative impact of rain on the firestopping. A 5-mm gap had been spotted in the beam-to-column connection after the construction. The manually installed connection hardware and various mass timber products from different manufacturers/suppliers could not achieve the fit as good as those typically produced using the CNC technology with high precision. Although firestop calking was applied to fill the gap, it could not completely seal the connection due to the obstruction by the exterior wall. Also, the lightweight steel exterior wall assemblies were not built as airtight as normal buildings (not well sealed in the joints with the mass timber beam, column and ceiling), providing passages for hot gases to move through and smouldering to continue during the 4-hour fire test and 1-hour post test operations. However, the issues were unique to the test structure only. Normal buildings would have the structural elements and connections tightly fitted using the CNC technology, and their envelope would be more airtight to limit air leakage and convection heat in order to meet the NECB.

Figure 43 shows the temperatures measured using embedded thermocouples in the B301-C104 beam-column-ceiling connection (see **Figure 32** for details of embedded thermocouples) in the back left corner during Test 2 and a photograph after the test. For the most part of the test, the temperatures measured inside the B301-C104 connection were only up to 100 °C. Towards the end of the test, the bottom thermocouple embedded in the connection detected a quick temperature rise from 100 °C to 400 °C; this thermocouple was installed at 80 mm away from the bottom side of the beam B301, indicating heat being transferred deeper to the connection. The bottom side of the beam charred away 125 mm from the interior portion as determined by measuring the exposed lengths of the screws which were used to reinforce the beam for the installation of the metal connector. This again was mainly because the exterior lightweight steel stud wall assembly did not have airtight joints with the beam and column, allowing the hot gases to pass through and smouldering to continue. However, normal buildings would be more airtight to limit the leakage and flame paths.

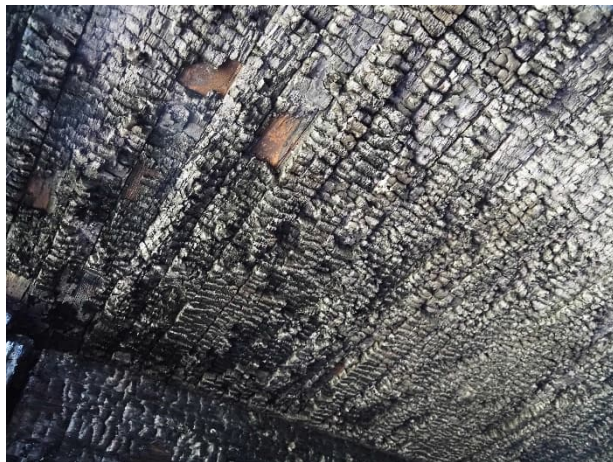
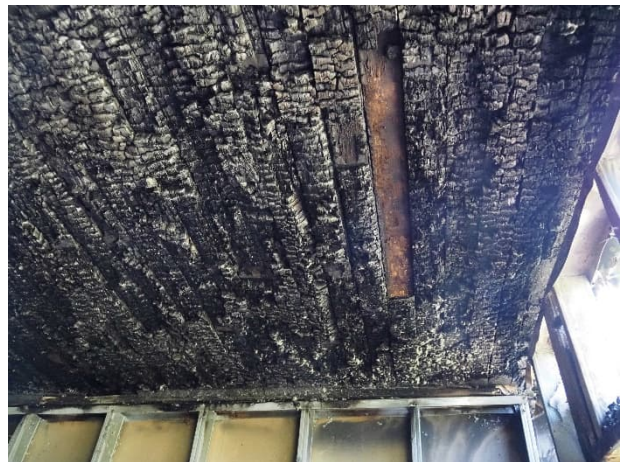
Figure 44. Some delamination from CLT ceiling in Test 2.

Minor localized delamination from the CLT ceiling was observed during Test 2 as shown in **Figure 44**. The delamination nevertheless did not lead to re-ignition nor fire regrowth.

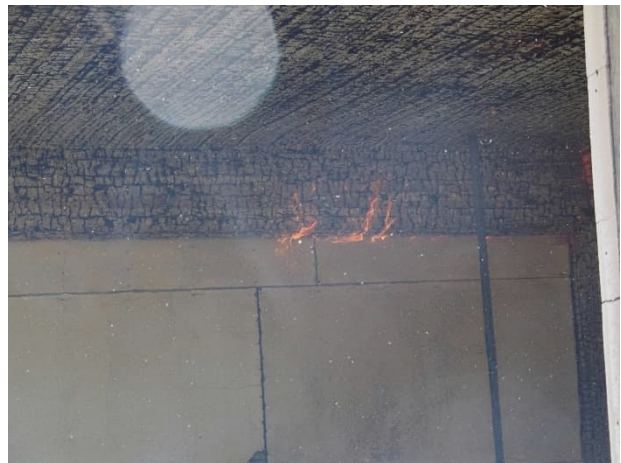
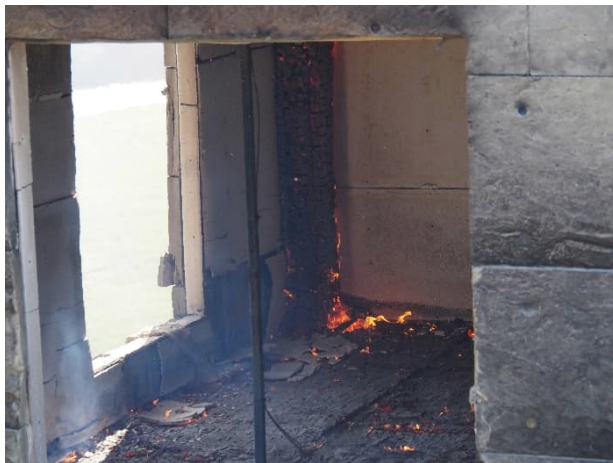
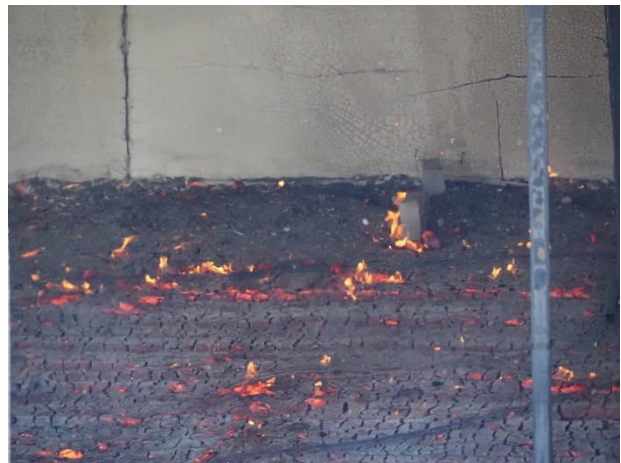
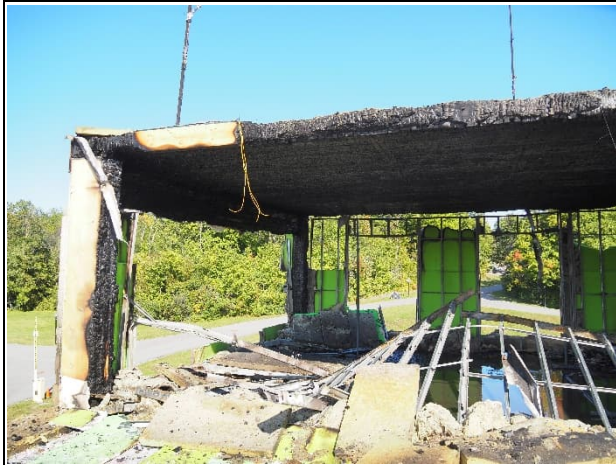
Figure 54. Structural elements at the end of Test 4.

DLT ceiling, B302 and C202

DLT ceiling, B302 and C106

CLT floor and C202

CLT floor

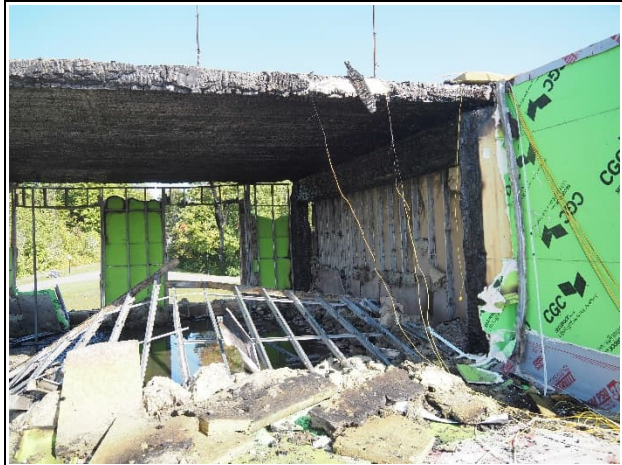
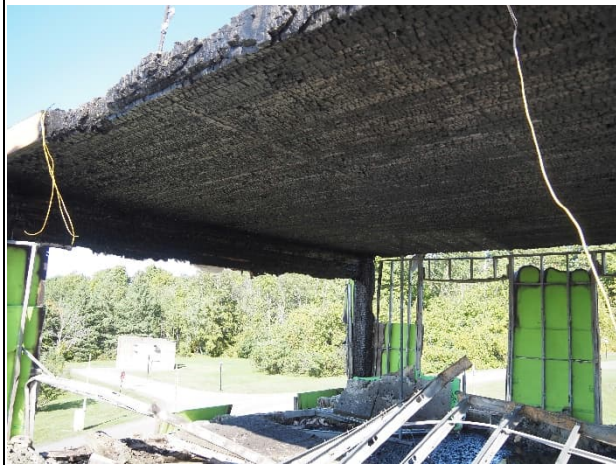
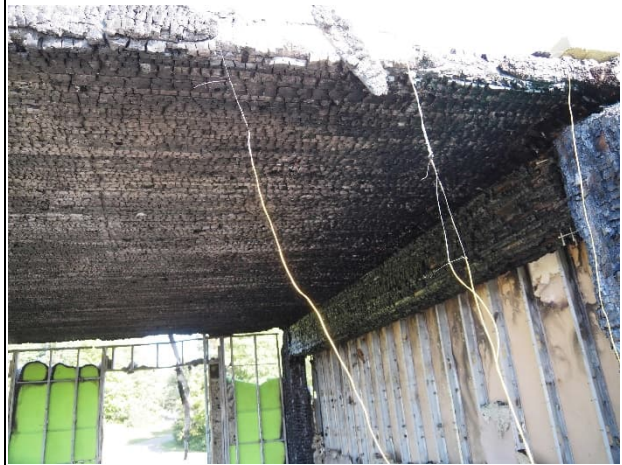
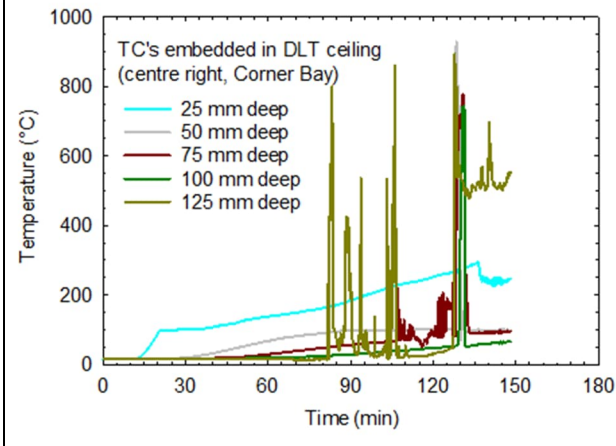
Figure 55. Charring on mass timber elements and temperatures in DLT ceiling (Test 4).

Figure 55 and **Figure 56** show some photographs of the mass timber structure after the test, along with the temperature profiles measured inside the exposed DLT ceiling. The temperatures certainly exhibited an ascending trend inside the DLT ceiling. One of the thermocouples inserted in the 125-mm depth produced several large temperature spikes which might have been inserted in-between the lamellas or into the finger joints of lumber boards where tiny gaps might have existed for hot pyrolysis gases to pass through. In spite of this, the general temperature profiles suggest the char depths in the DLT panels being over 75 mm at the measurement locations (where the temperatures reached above 300 °C).

DLT ceiling, C105-B303-C108

DLT ceiling, C202-B302-C106

DLT ceiling, B303

DLT ceiling, B302

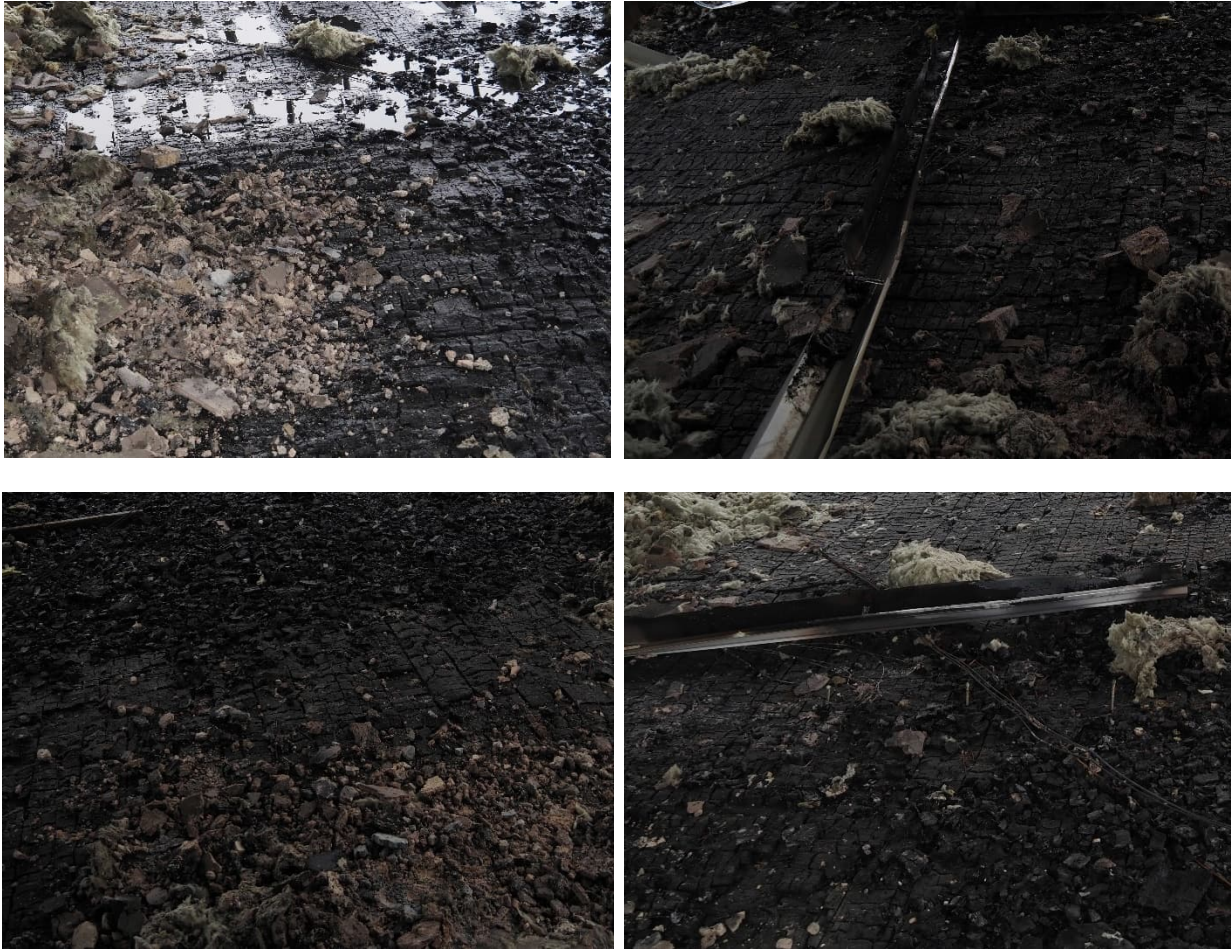
Figure 57. Char depths (mm per exposed side) on ceiling, beam and columns in Test 4.

Char measurements were conducted after Test 4. The char depths were measured with 1.8 m spacing across the ceiling and along each beam, 2.4 m spacing across the floor, and at 0.75 m, 1.5 m and 2.25 m high along each column. For the beams and columns, each measurement involved two drillings perpendicular to each other to determine the char depths on all exposed sides (B302 and C202 being exposed from three sides; B303, C105, C108 and C106 being exposed from two sides). **Figure 57** shows schematically the measured char depth per exposed side.

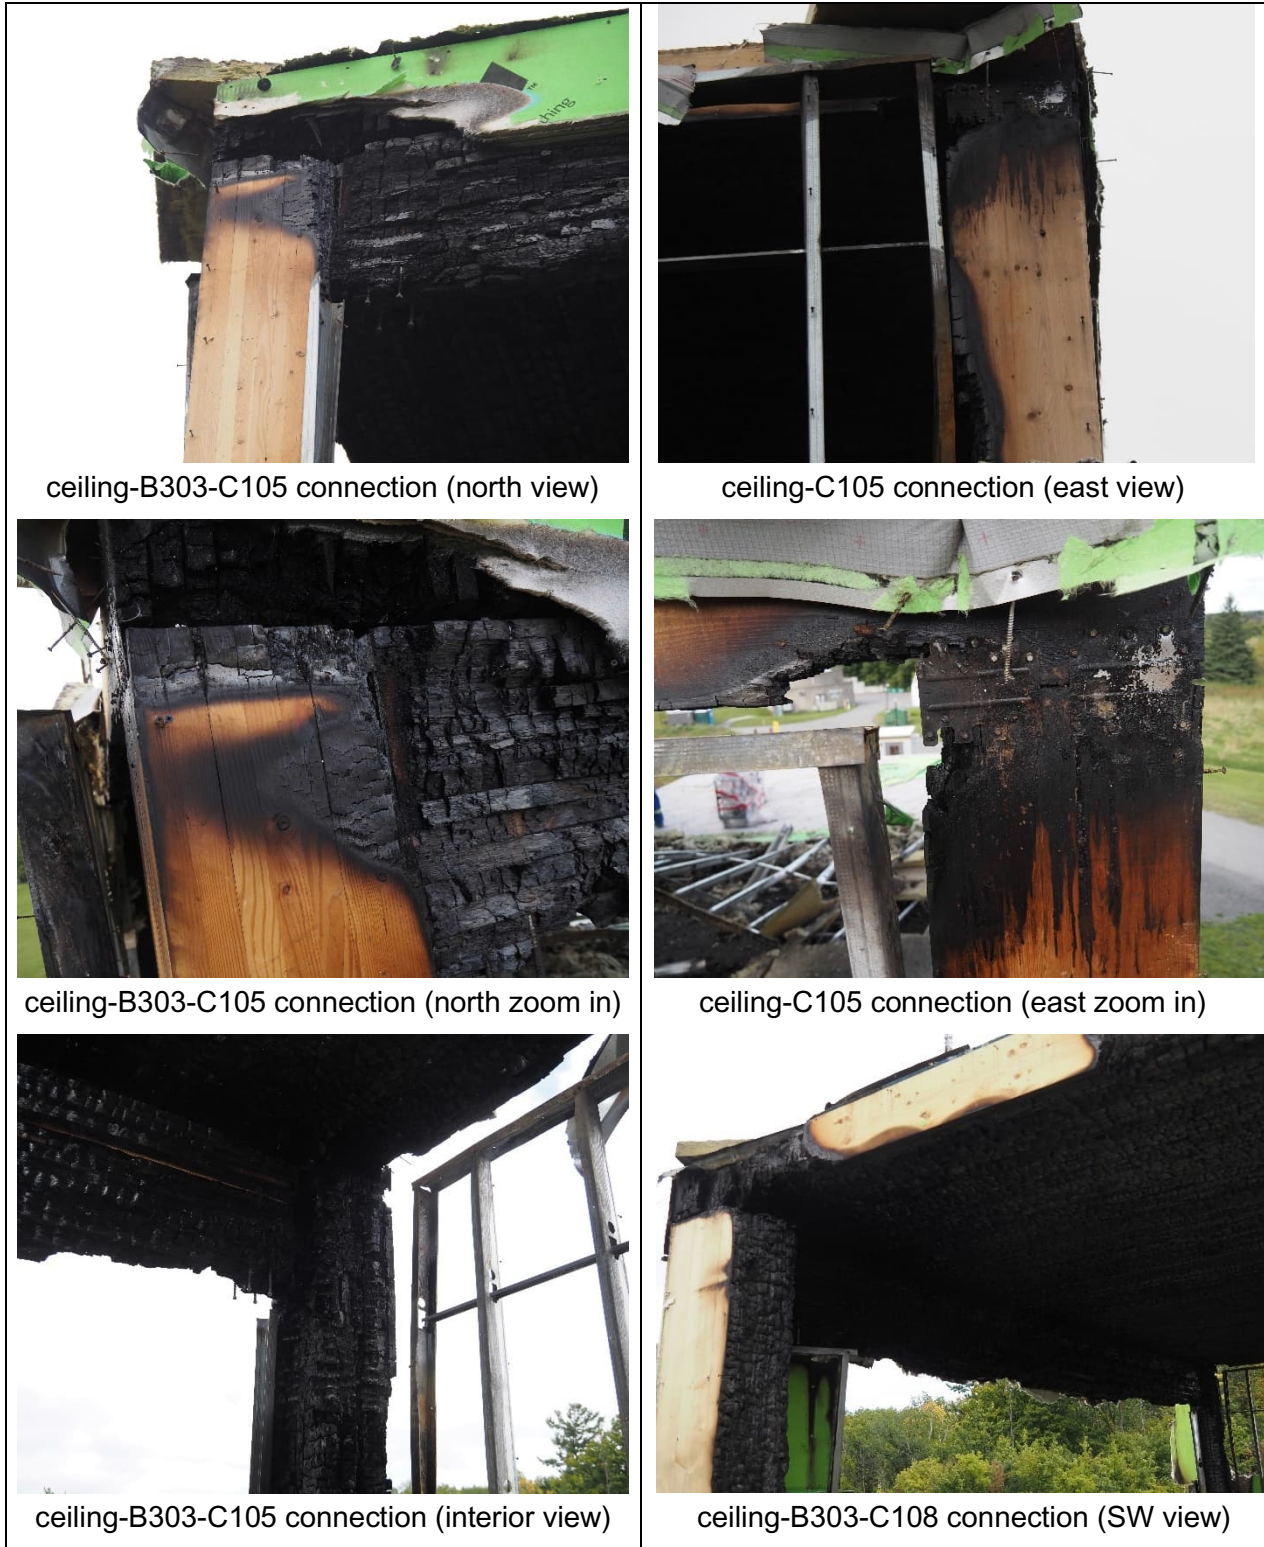
Figure 58. Charring on structural elements connected to beam B303 (Test 4).

Greater char depths than average occurred at several locations. **Figure 58** shows the B303 beam-column-ceiling connections after the test. The DLT ceiling panel charred away 125 mm on this exterior corner. Beam B303 even charred away 28 mm from the exterior side (behind gypsum sheathing) near the connection to column C105 with the edge of the metal connector (RICON XL 390x80) visible.

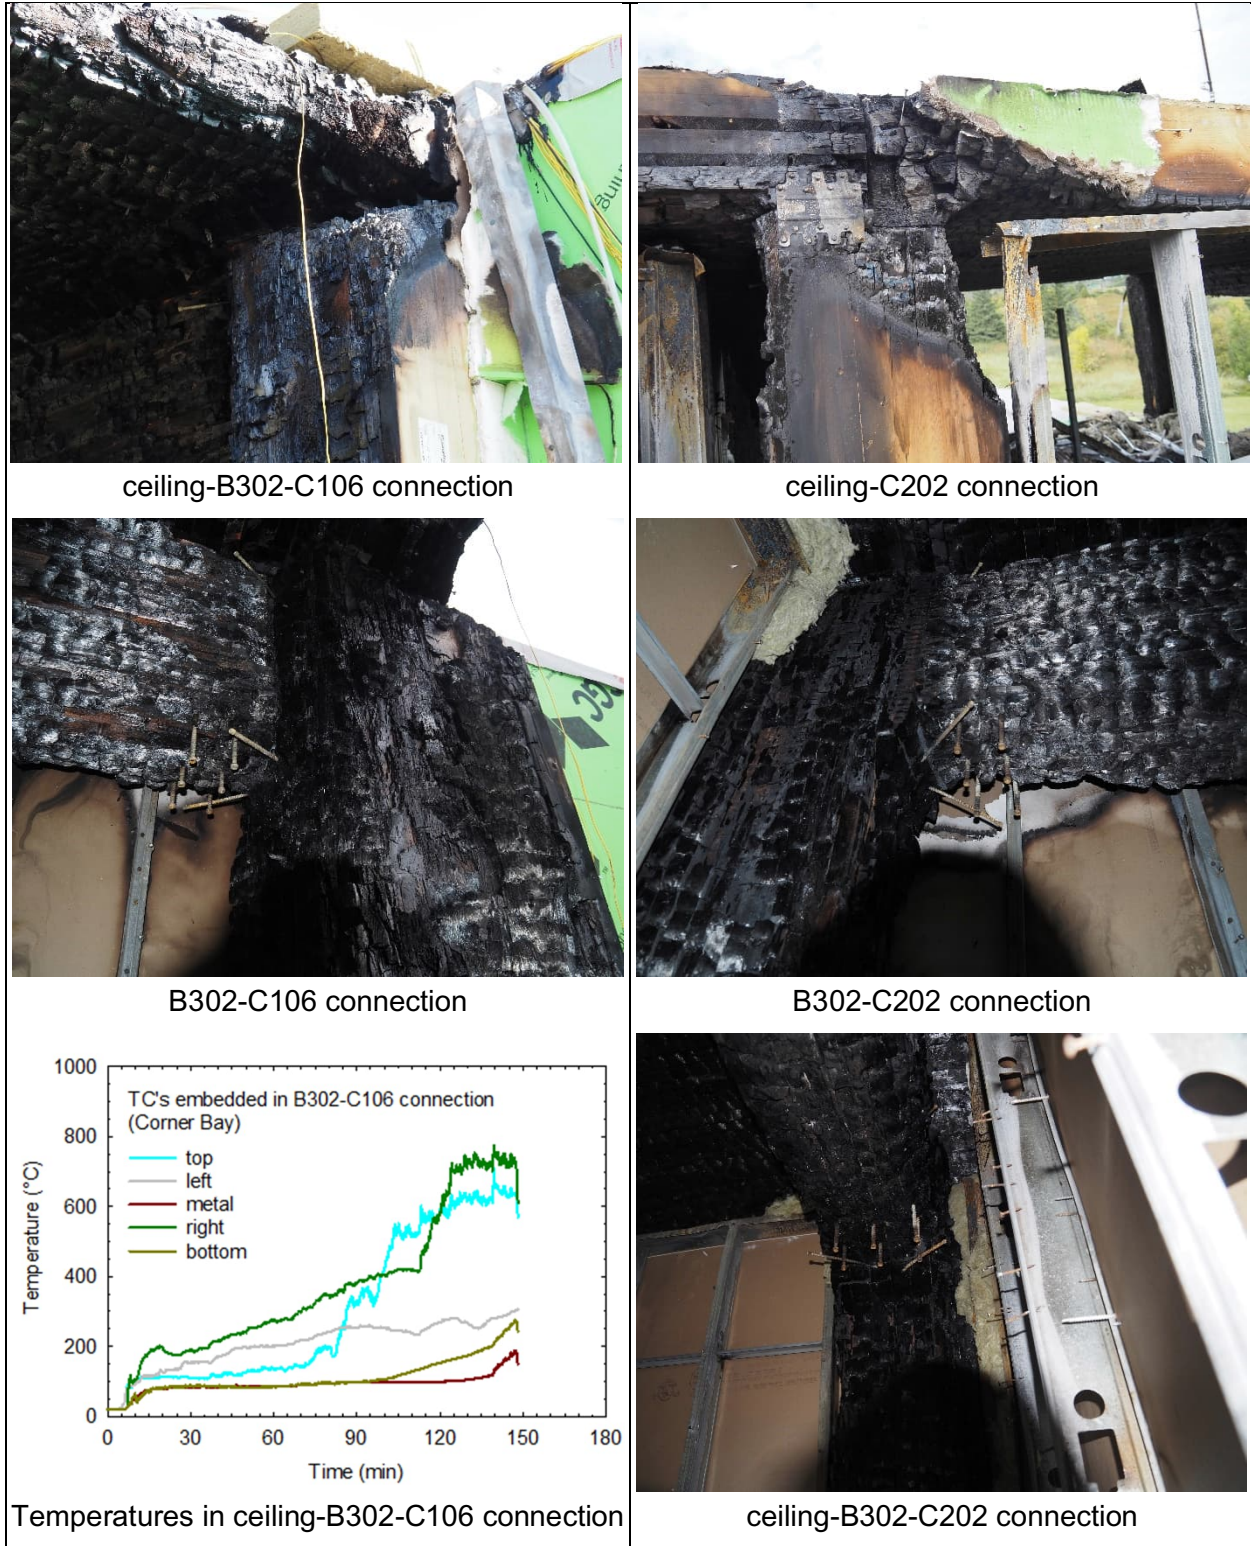
Figure 59. Charring on beam B302 and connected elements and connection temperatures (Test 4). (Zoom in and zoom out to the corner from interior and exterior)

Figure 59 shows the beam B302 beam-column-ceiling connections after the test. At the ceiling-B302-C202 connection, the top portion of column C202 reduced from the 395 mm × 395 mm cross section to 225 mm × 325 mm (charred away 70 mm from the room-facing side, 85 mm from each of the other two exposed sides). This connection experienced the severest heat penetration from three exposed sides of B302 and C202.

Figure 59 also shows the temperature profiles inside the ceiling-B302-C106 connection during the test. All temperatures within the connection exhibited an ascending trend (see **Figure 48** for details of embedded thermocouples). The right thermocouple in the connection detected 300 °C at 70 min, 600 °C at 120 min and 750 °C at 140 min while the top thermocouple detected 300 °C at 90 min, 600 °C at 120 min and 650 °C at 140 min. Among all four beam-column-ceiling connections, this connection experienced the least heat penetration, which means that the other three connections would have endured at least similar thermal conditions.

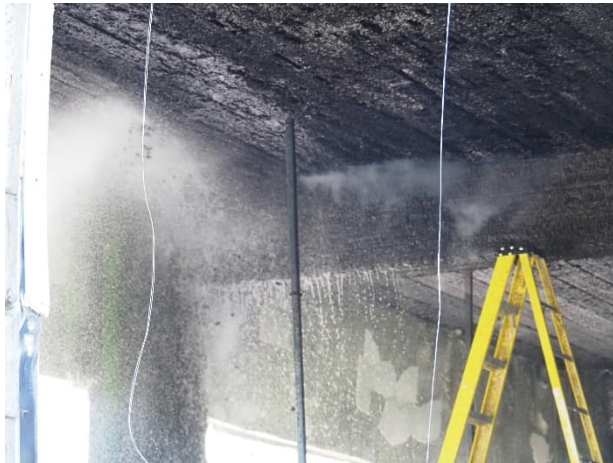
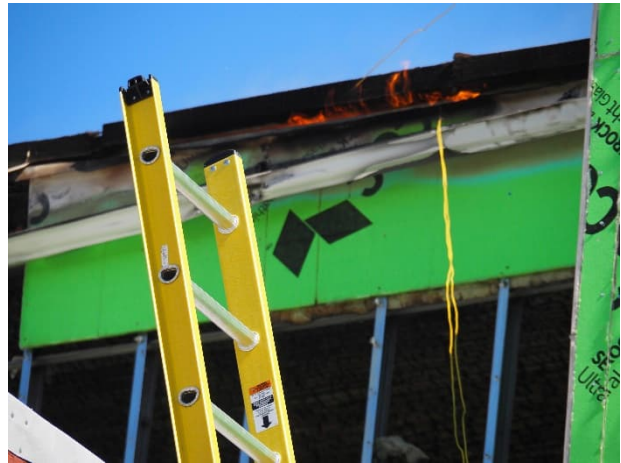
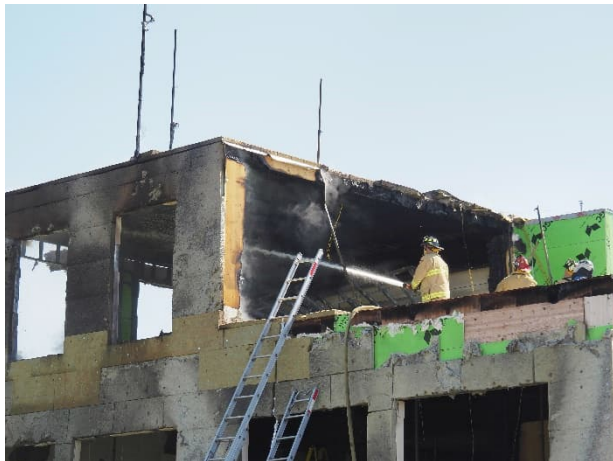
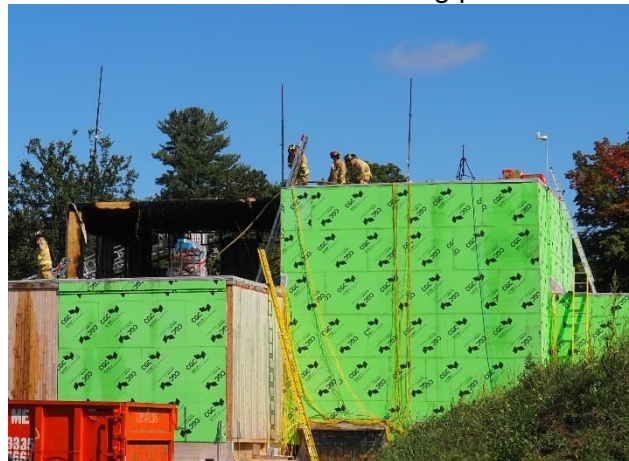
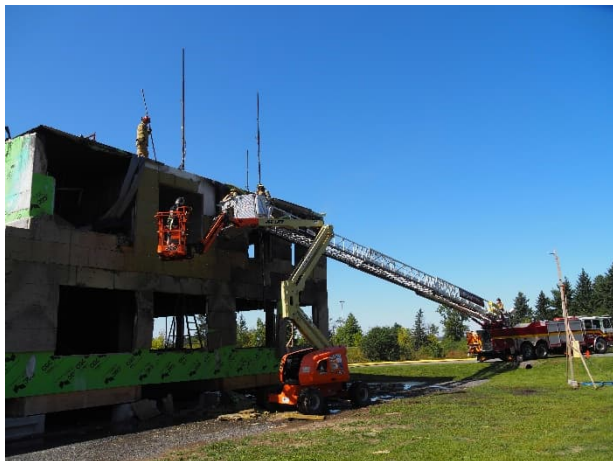
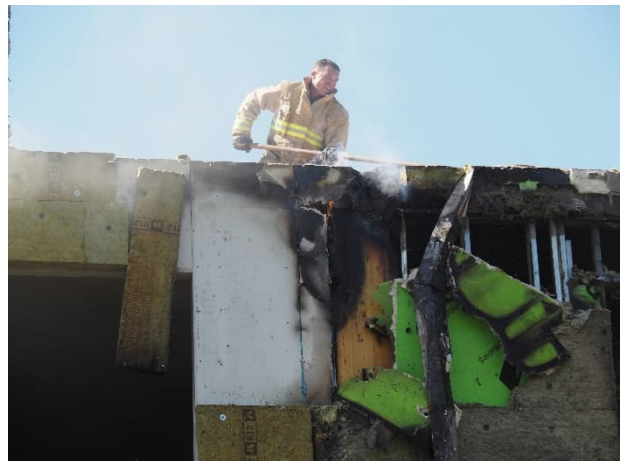
Figure 63. Post fire operations after Test 4.

At the end of Test 4, the CLT floor was glowing red, flickers were around the DLT ceiling perimeter and on the beams and columns. Post fire operations lasted for two hours. **Figure 63** shows some photographs of the post fire operations. For the first 20 min immediately after the test, hose streams were directed to the interior using multiple short and pulsed water sprays for a total of 150-s spray time. Visible flames were fairly easy to extinguish but deep-seated fires hidden in joints and junctions kept coming back, particularly in the southeast upper corner where beam B302, column C202 and the DLT ceiling met. The rest of the operations switched to the outside attack, involving removal of the exterior walls and roof covering to directly attack the hidden fires and hot spots in the joints and junctions. All hot spots were fully extinguished by the post test operations. The test structure maintained its integrity and facilitated the fire department intervention. Subsequent fire watches observed no more hot spots.

hose streams to the interior

small flames in the DLT ceiling perimeter

attack hidden fire in B302, C202 and DLT connections

attack hidden fire in B302, C202 and DLT connections (zoom in)

removal of exterior walls to attack outside

removal of roof cover to attack outside
