Client Report (National Research Council of Canada. Construction); no. A1-018329.1/A1-018487.1, 2023-05-10

Large-Scale Fire Tests of A Mass Timber Building Structure for MTDFTP

Report No.: A1-018329.1/A1- 018487.1

Report Date: 10 May 2023

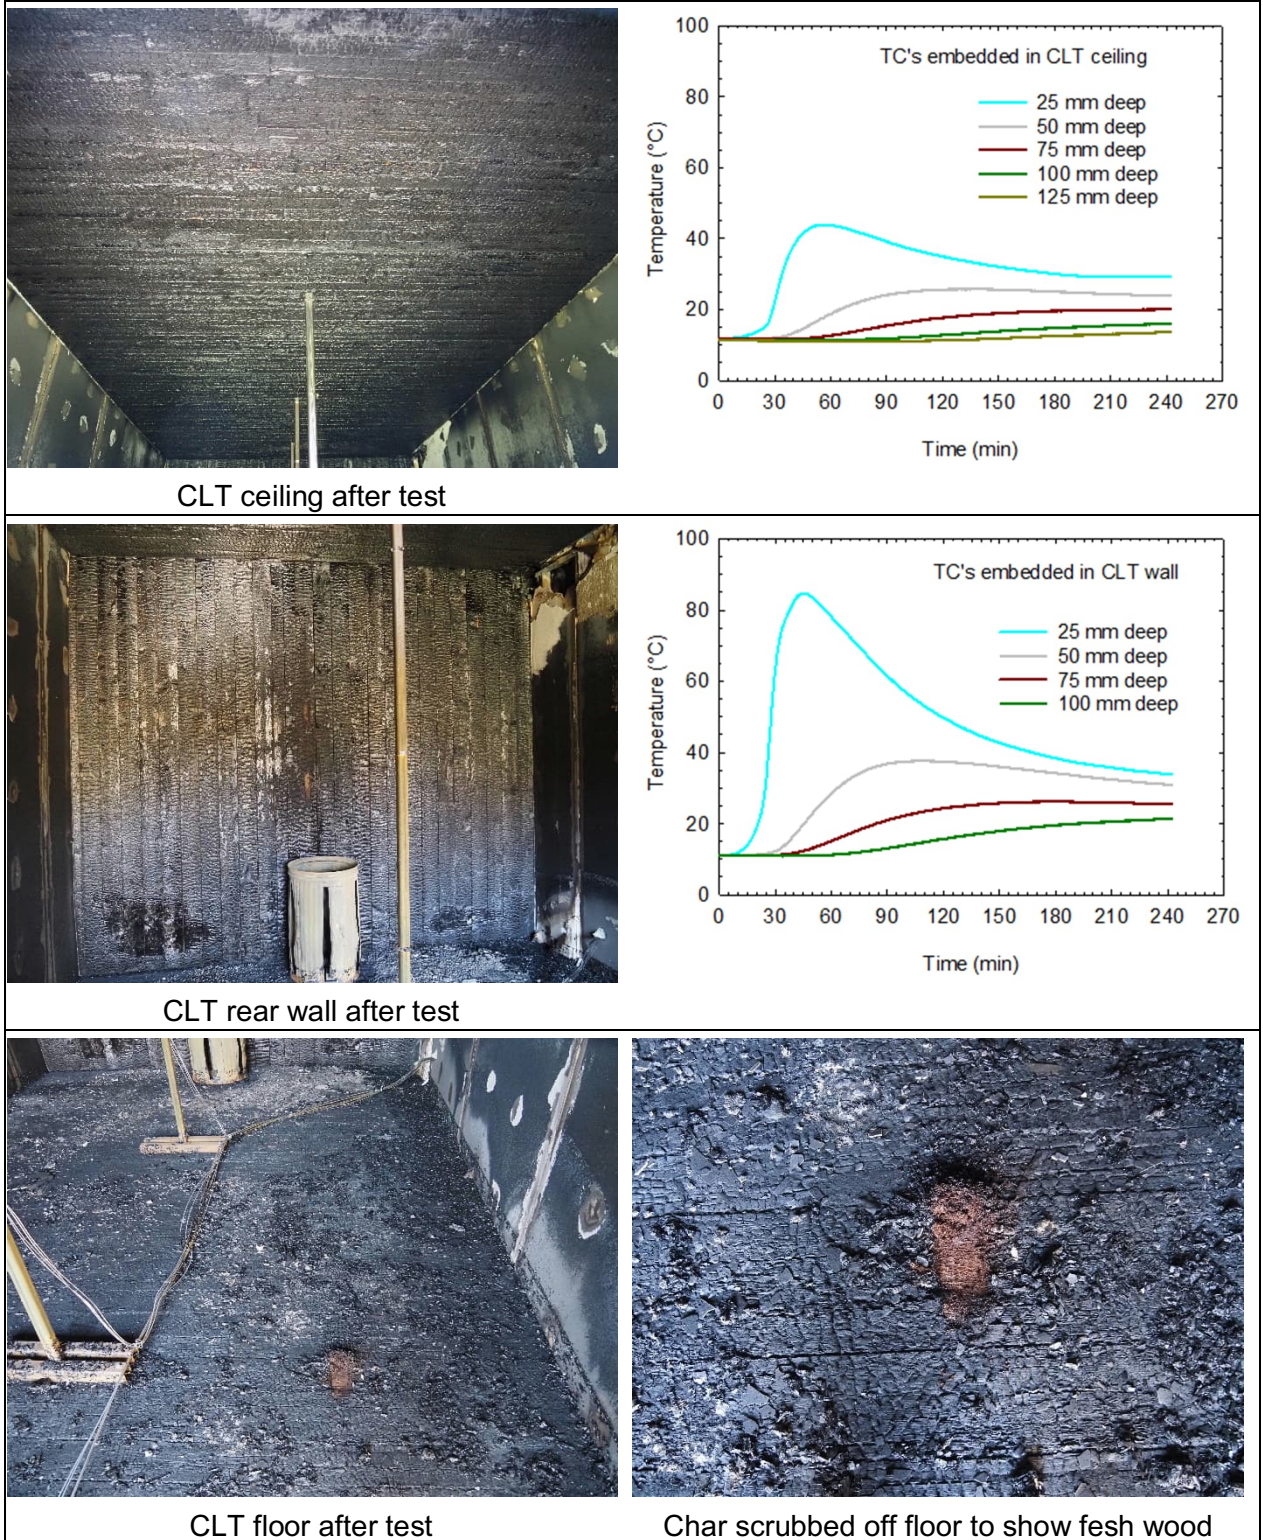
Figure 68. Charring and temperatures in CLT ceiling, wall and floor (Test 3).

Since the CLT floor, wall and ceiling only experienced up to three minutes of flaming combustion, char depths were generally quite low – up to 10 mm on the CLT floor (charring on the floor was accumulated from both Test 1 and Test 3), 5 mm on the CLT shaft wall and 2 mm on the ceiling. **Figure 68** shows the charring and temperatures in the CLT ceiling, wall and floor panels. The embedded thermocouples in the CLT panels indicated that the maximum temperatures in 25 mm deep were below 45 °C in the ceiling and below 85°C in the shaft wall, confirming the CLT having only the surface charring.

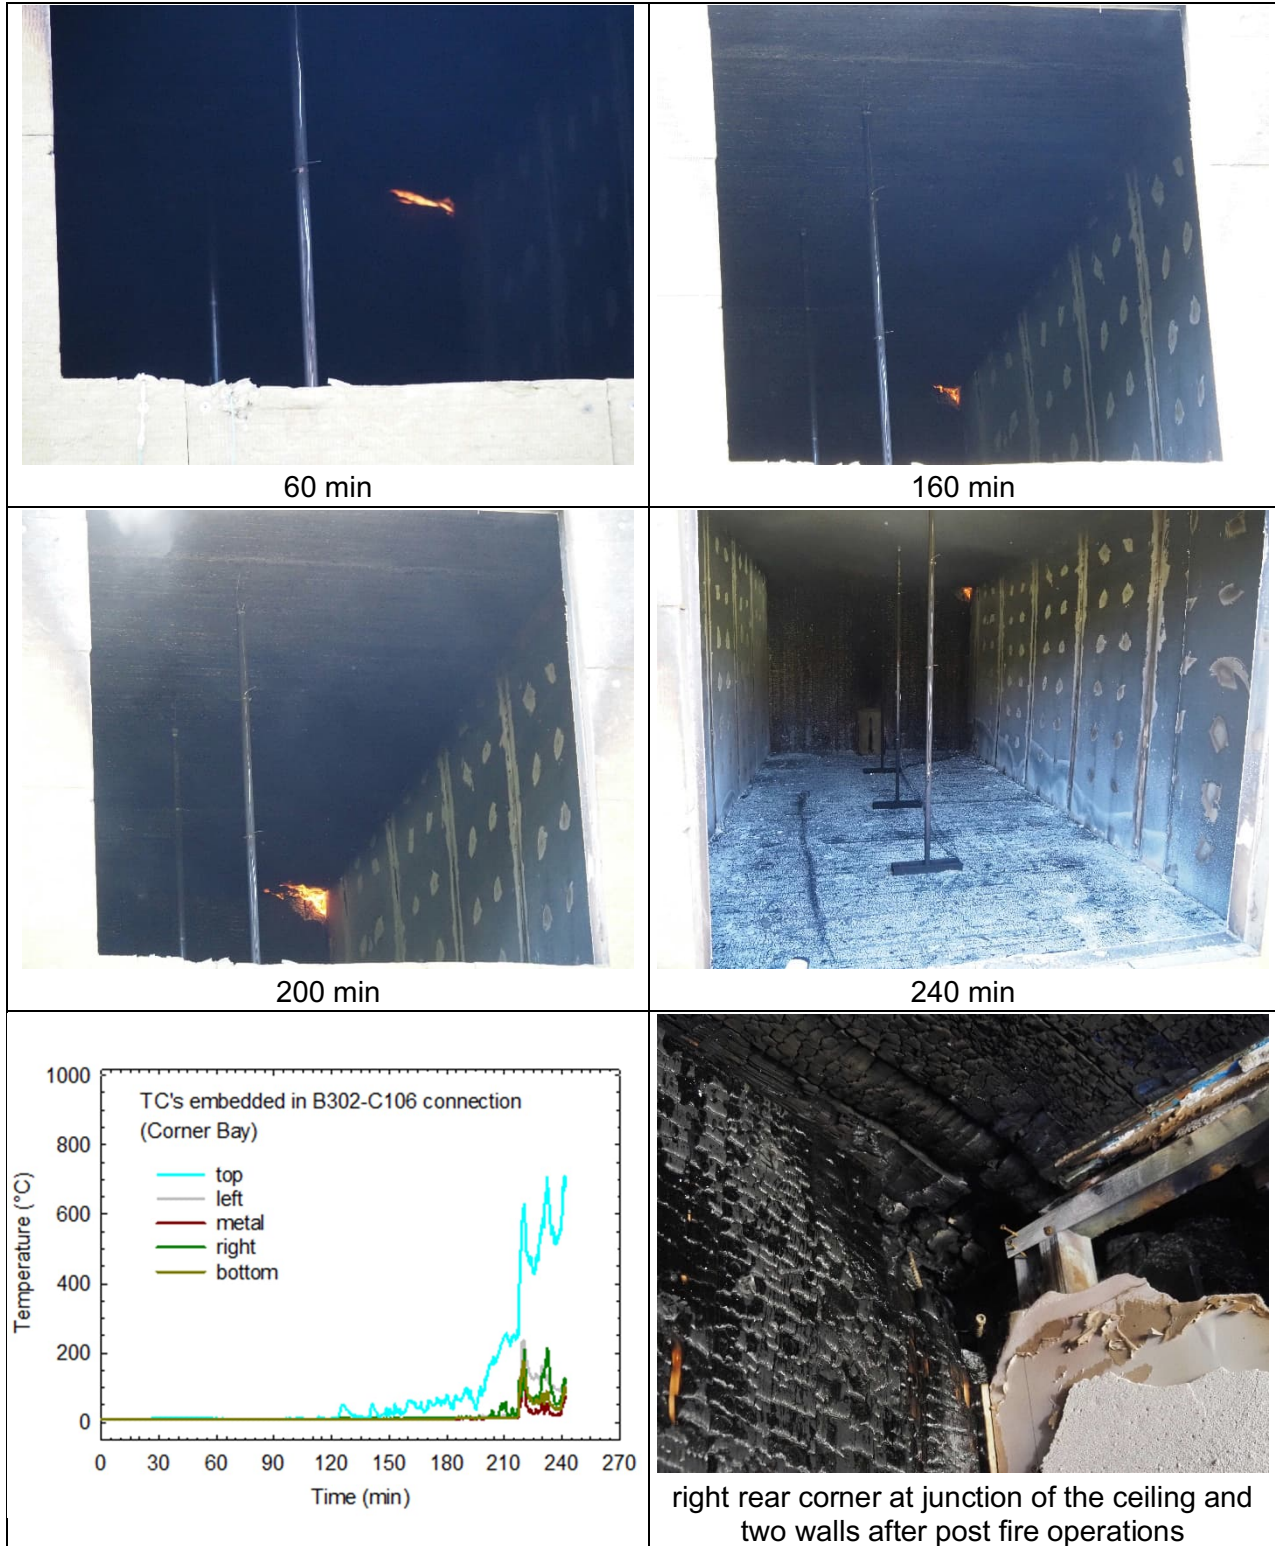
Figure 69. Intermittent small flame in top right rear corner and temperatures in neighbour's corner.

There was deeper charring on the ceiling directly above the garbage bin, along the junction of the CLT ceiling and the CLT wall, and particularly in the top right back corner where the ceiling and two walls met. **Figure 69** shows the intermittent small flame in that rear corner during the test and the charring damages to the CLT in that corner. It also shows the temperature profiles measured in the neighbouring corner in the adjacent space using the embedded thermocouples in the B302-C106 connection (which had been installed for the preceding Test 4). This neighbouring corner in the adjacent space experienced up to 700 °C during this test. Again, this was due to the suite separation wall between Suite B and Suite C not being airtight. After the preceding test (Test 4 in Suite C), the suite separation wall had only double layers of 15.9 mm Type X gypsum board on the Suite B side of the steel studs without any insulation or gypsum board on the other side, which provided passage for air and flames in the junction during Test 3.
